Manhole Inspection Summary

Manhole # S11EE2013MH

Insp Date: **10/10/06 9:59 AM**

Location Address: **2209 CROSS COUNTRY BLVD**

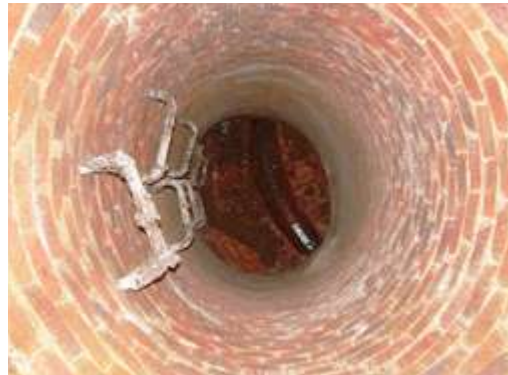
Top View

Adjustment and Corbel infiltration.
Evidence of surcharge - Bench debris.
Channel debris.

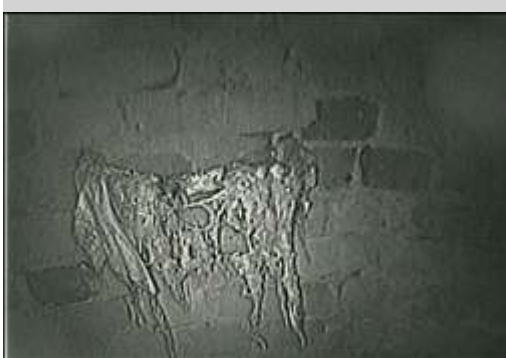
Evidence of surcharge

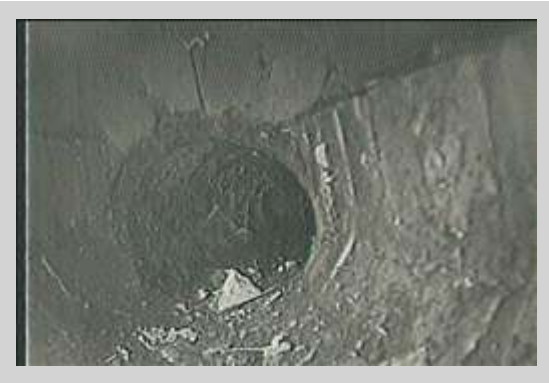
8 in. Circular Gravity Sewer Pipe Out @ 12 O'Clock

Deposits: ☐ None ☐ Mud ☐ Sludge ☒ Debris ☒ Grease

Silt Depth: **0.5** (in.) Deposits Extent: **Light**

Infiltration: **Evidence** Pipe Seal Cond: **Unknown**

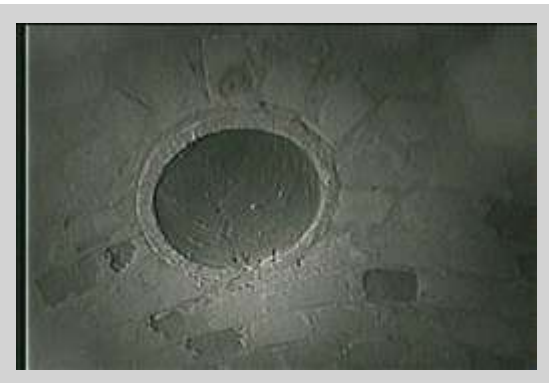
8 in. Circular Gravity Sewer Pipe In @ 5 O'Clock

Infiltration: **Evidence** Pipe Seal Cond: **Roots**

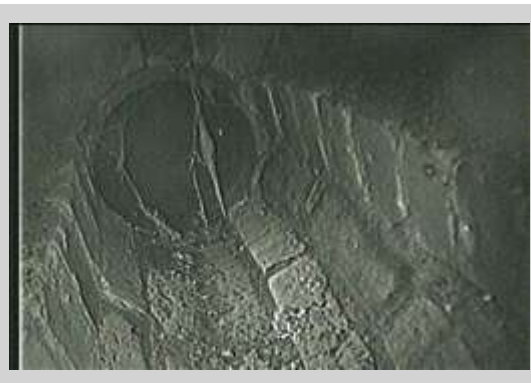
Drop In @ 5 O'Clock

Drop: **Outside** Rod and Bar

Drop Condition: **Open**
